Archaeological Data Concerning the History of the Evangelical Church in Dealu Frumos, Sibiu County

DANIELA MARCU ISTRATE*, DELIA MARIA ROMAN**

Keywords: Evangelical church, Dealu Frumos, Sibiu County, planimetry, cemetery.

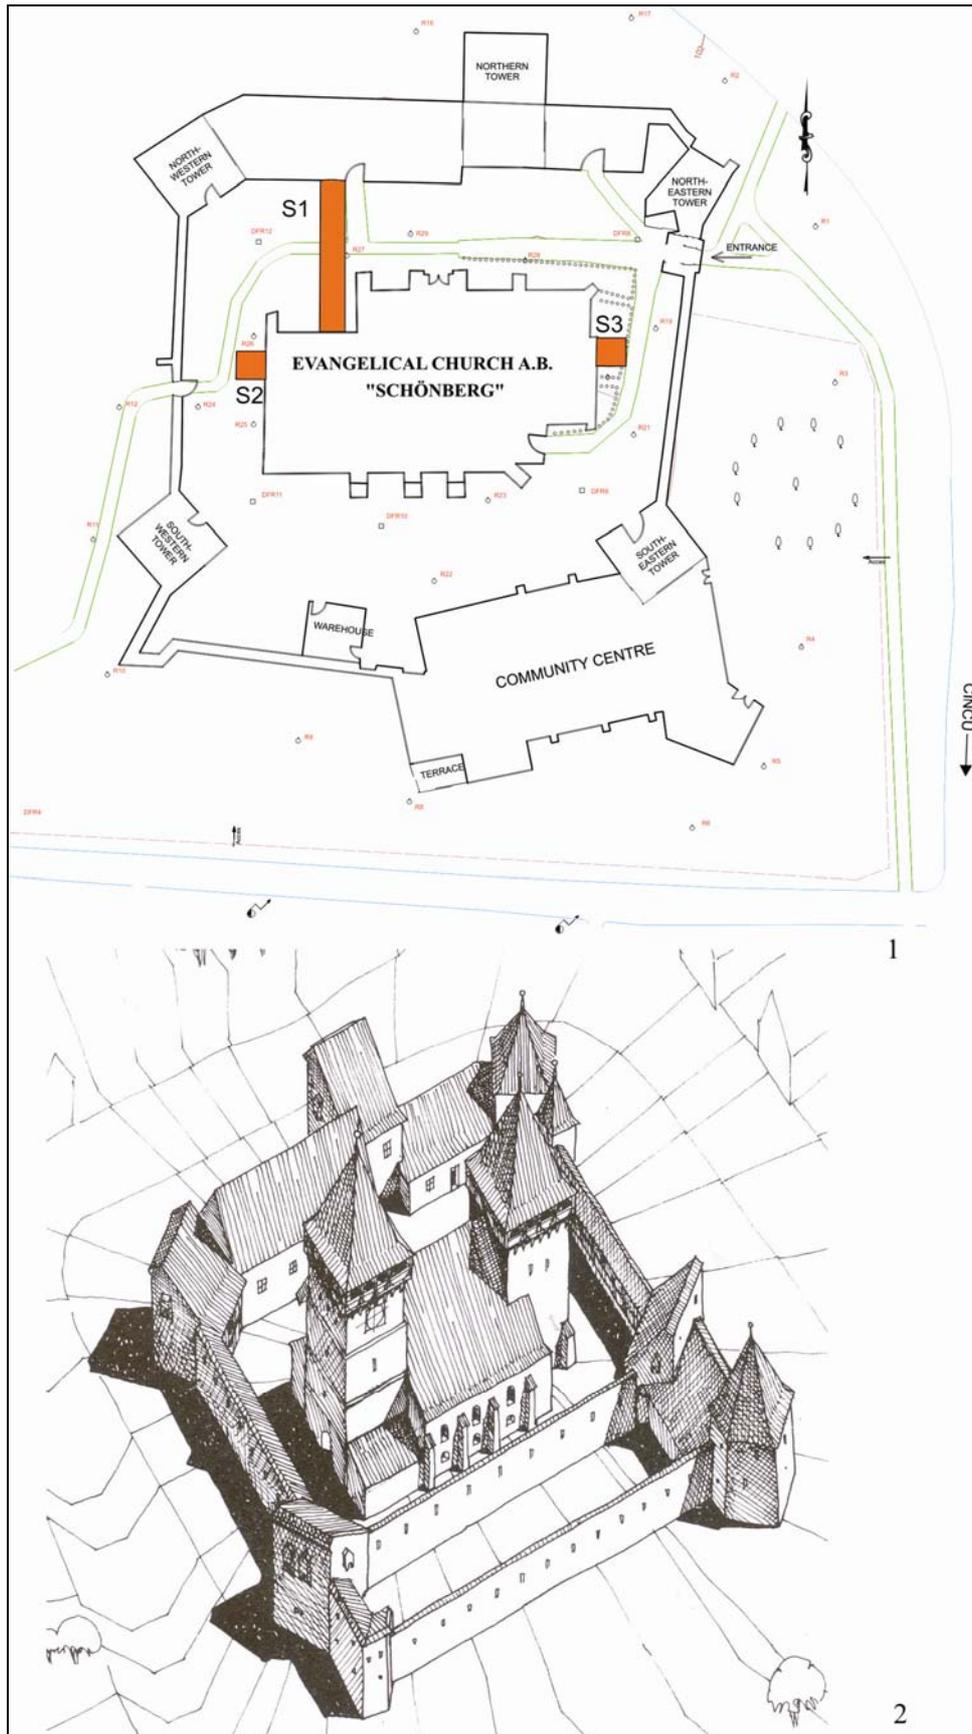
Pl. 1. 1. General plan of the fortified ensemble in Dealu Frumos with marking of the archaeological excavations.
 2. Iso-metric reconstruction (apud Hermann Fabini, *op. cit.*, p. 679).

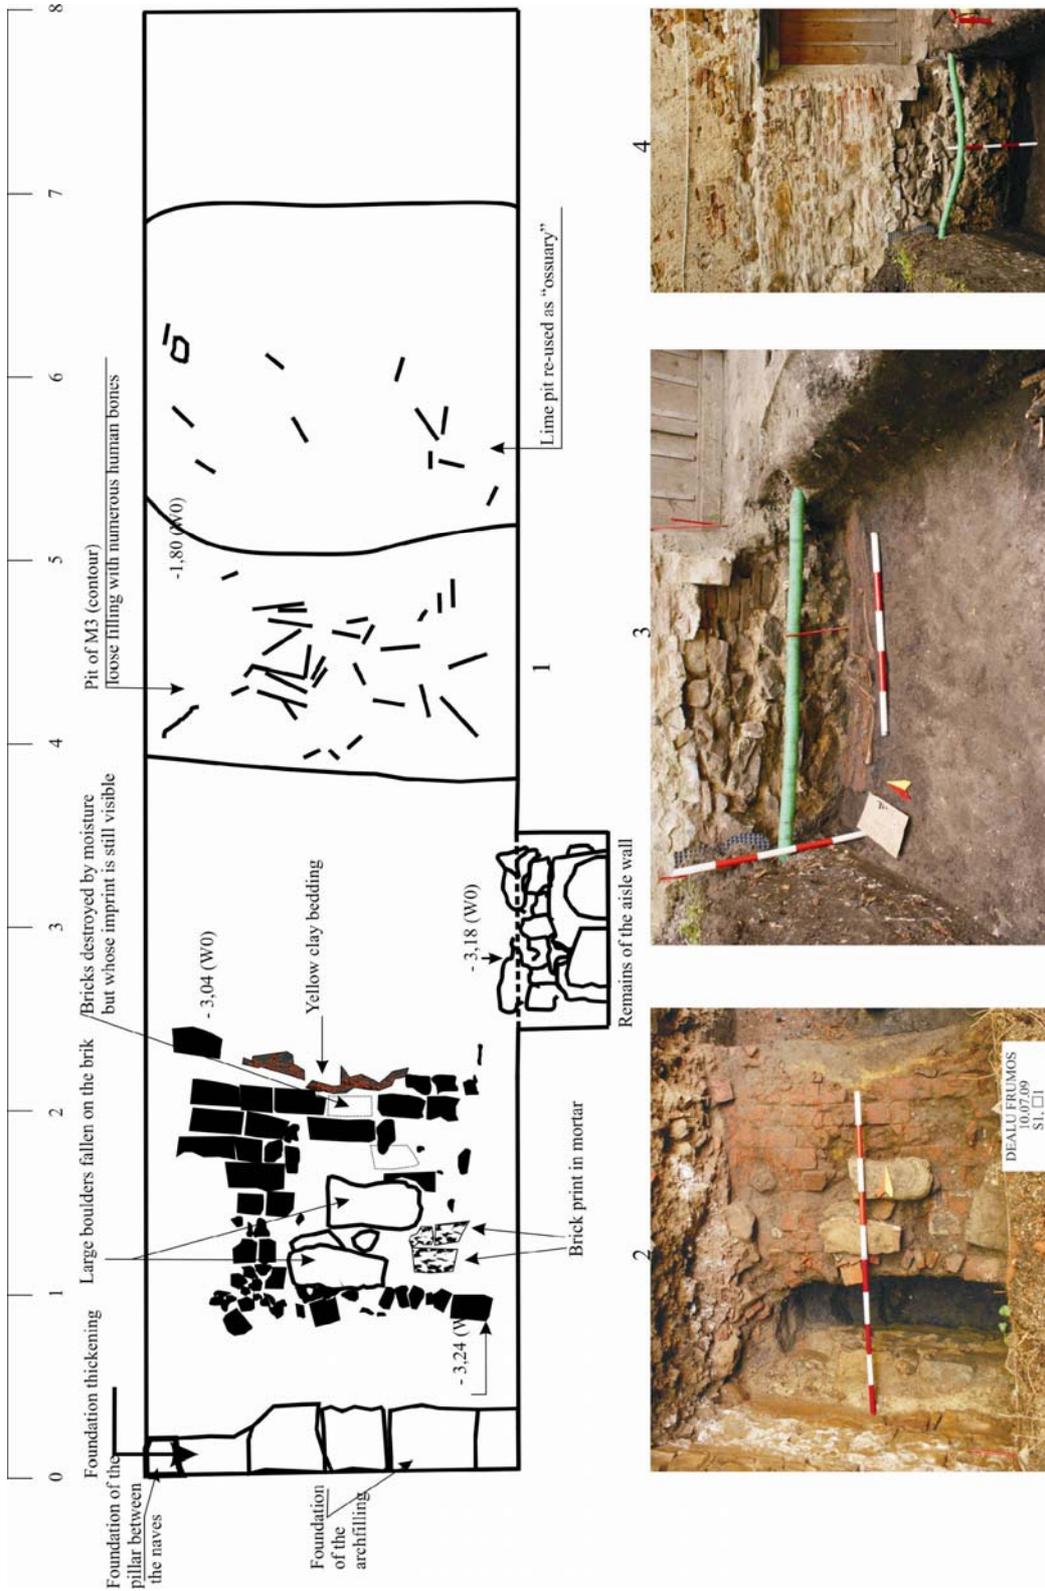
Pl. 2. 1. General plan of trench 1 with marking of the main discovered vestiges. 2. Detail of the brick floor discovered inside the ruin of the northern aisle. 3. Detail of the foundation of the old curtain wall. 4. General view toward the current building on the northern side of the enclosure.

- Pl. 2. 1. General plan of trench 1 with marking of the main discovered vestiges. 2. Detail of the brick floor discovered inside the ruin of the northern aisle. 3. Detail of the foundation of the old curtain wall. 4. General view toward the current building on the northern side of the enclosure.

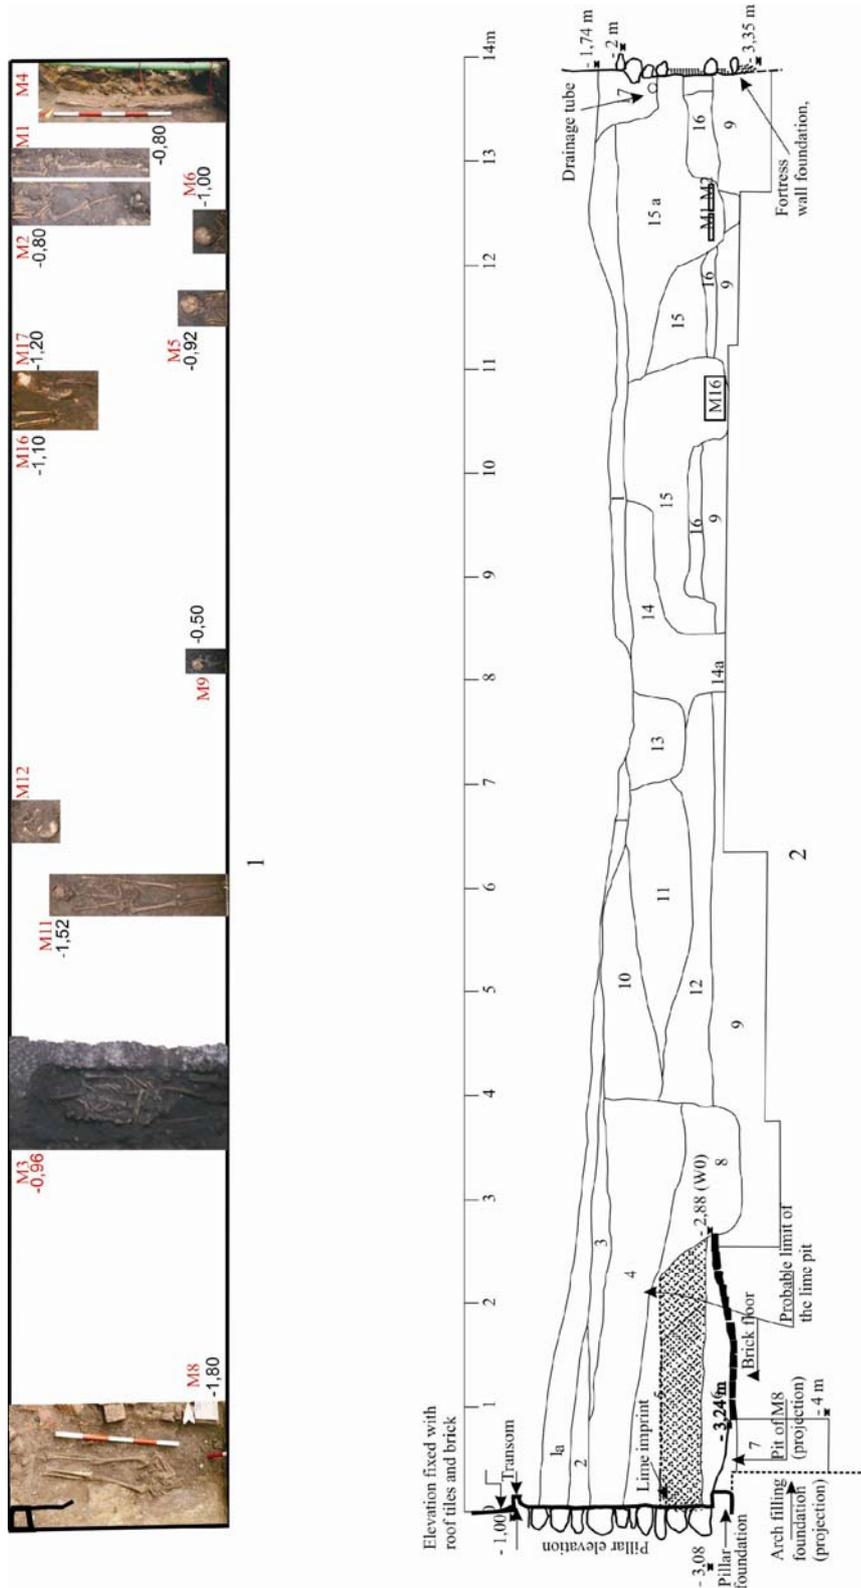
Pl. 3. 1. General plan of trench with marking of the graves. 2. Western profile of trench 1.

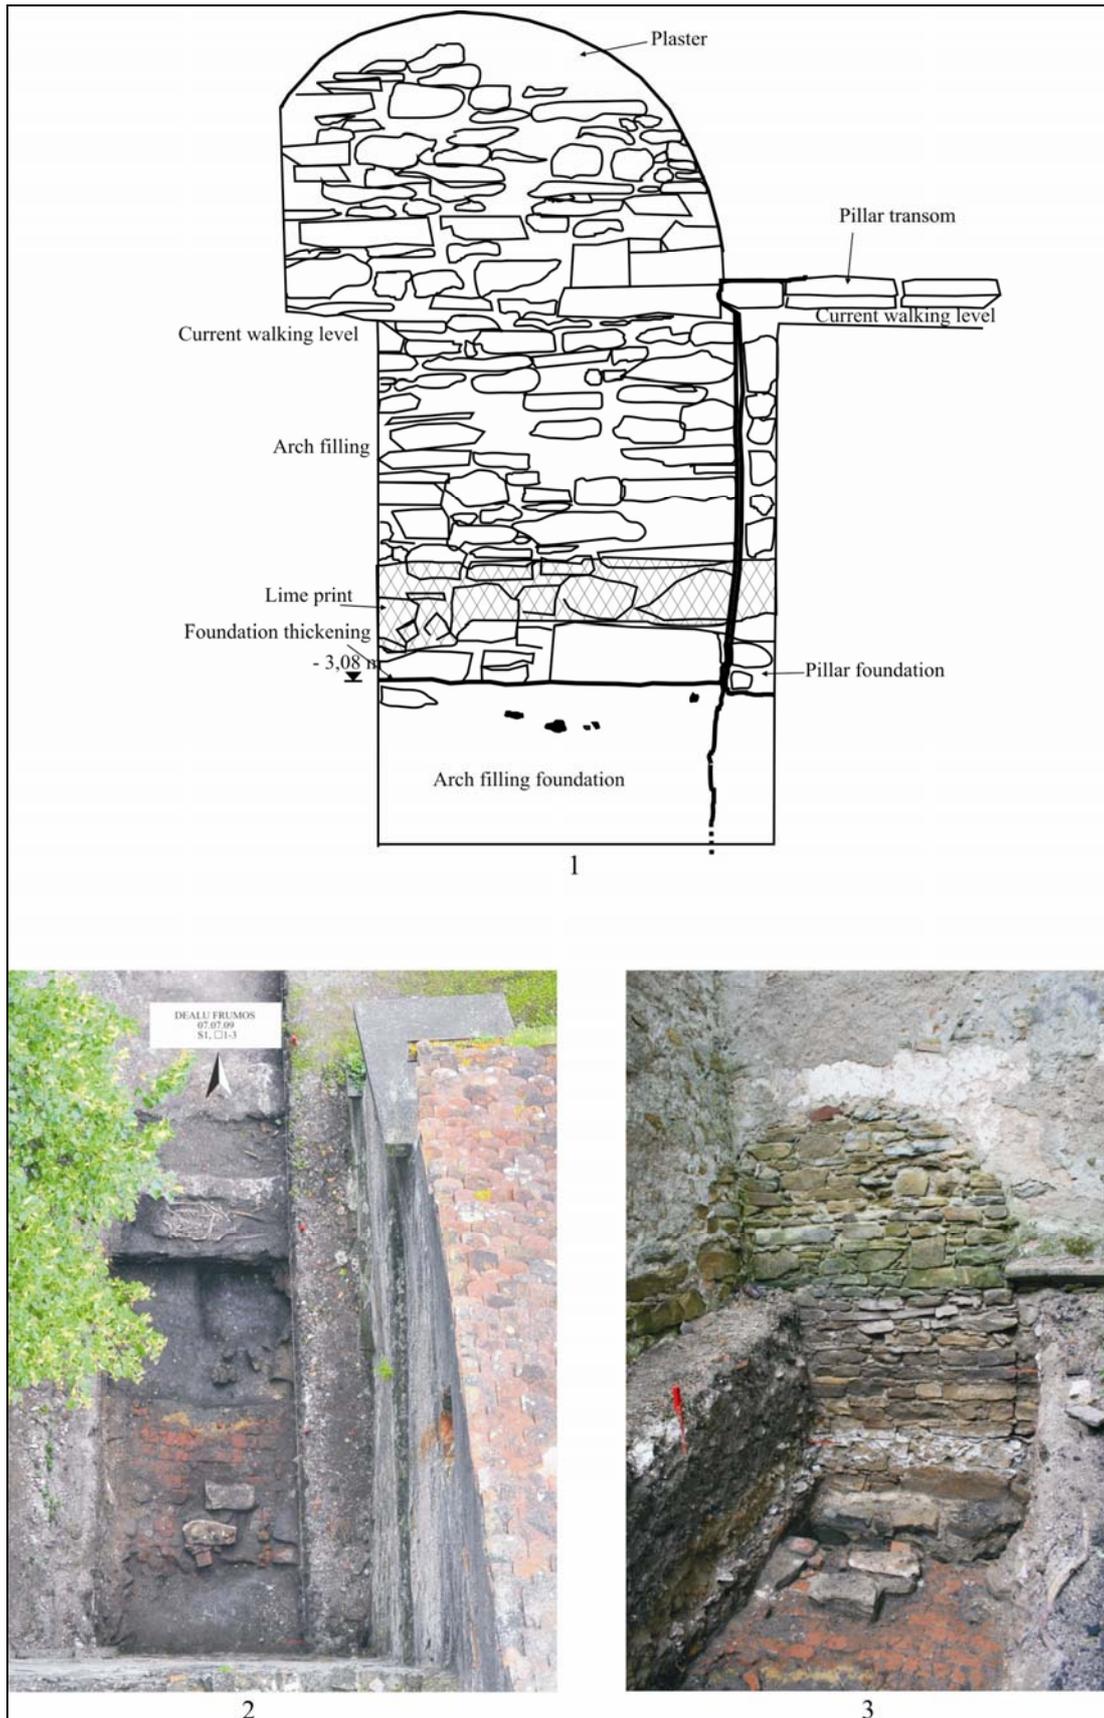
Pl. 4. 1. Current, northern face of wall of the church, next to trench 1. 2. General view of trench 1. 3. Bird's eye view of the current church wall next to the trench.

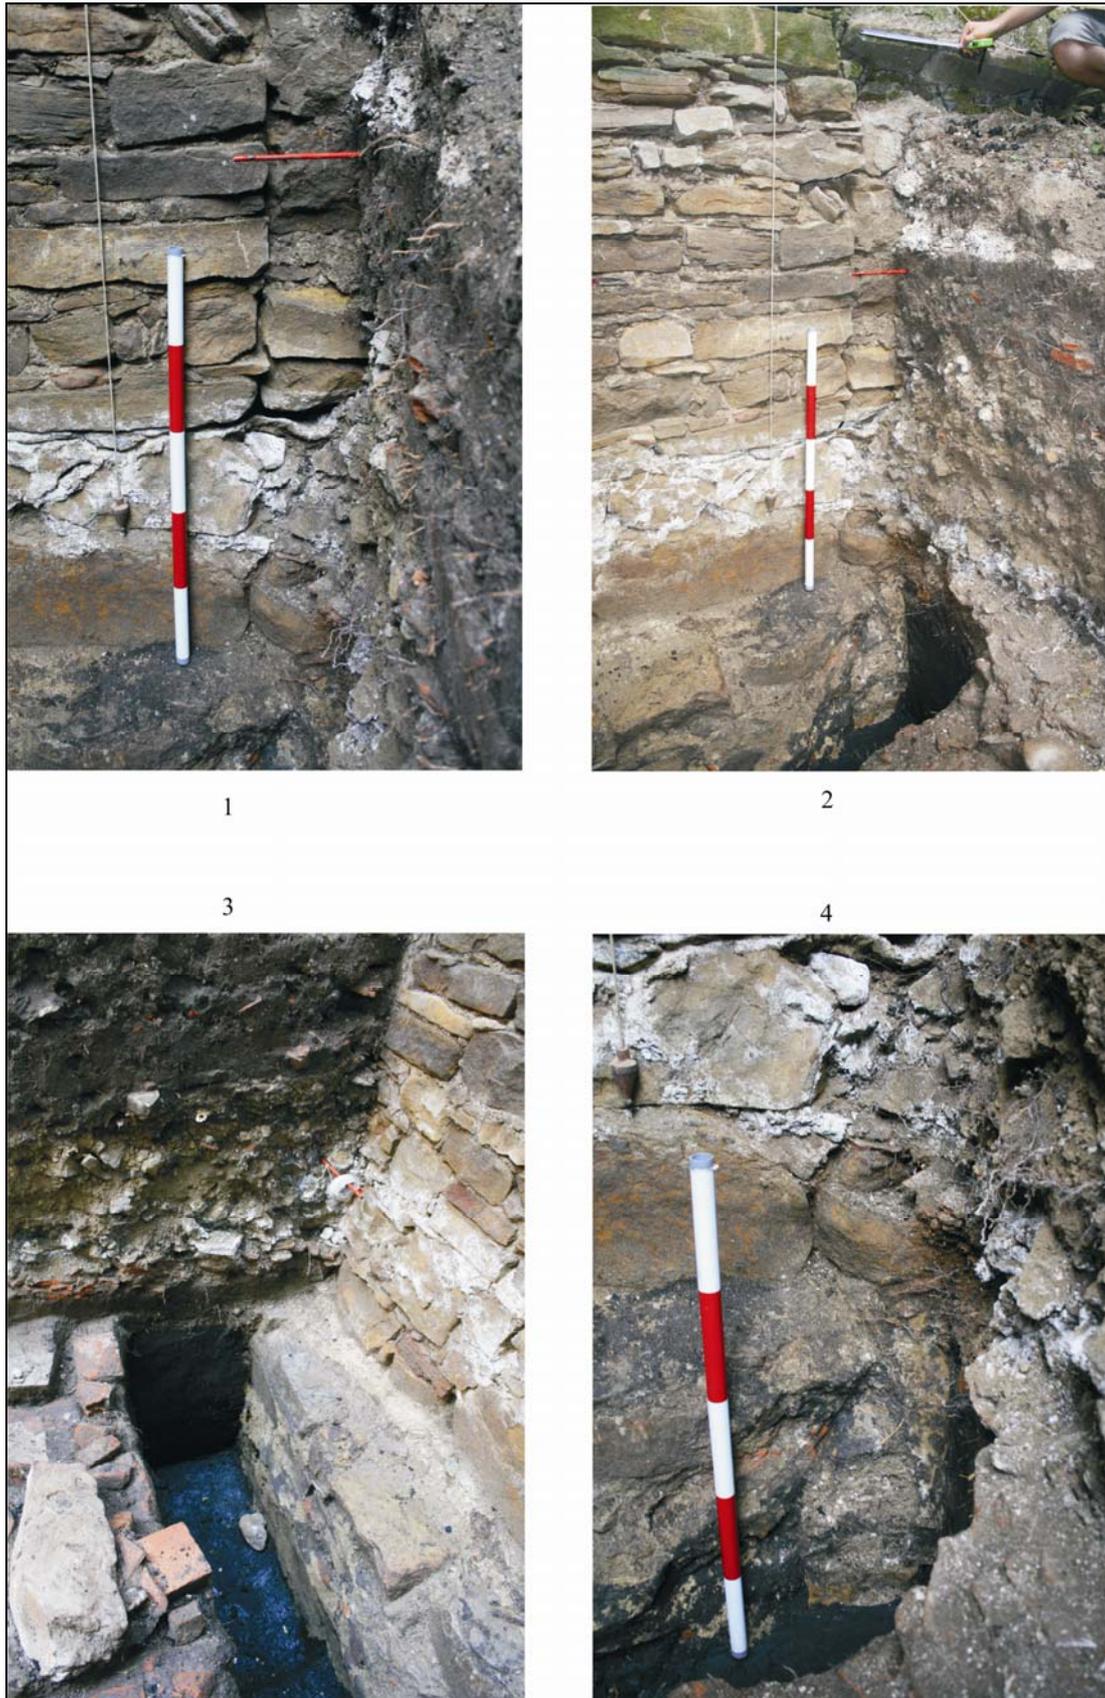
Pl. 5. 1-2. Current church wall, filling of the arch and original walling of the pillar, face of wall details.
3-4. Details of the filling walling in the area of the arch and next to the pillar.

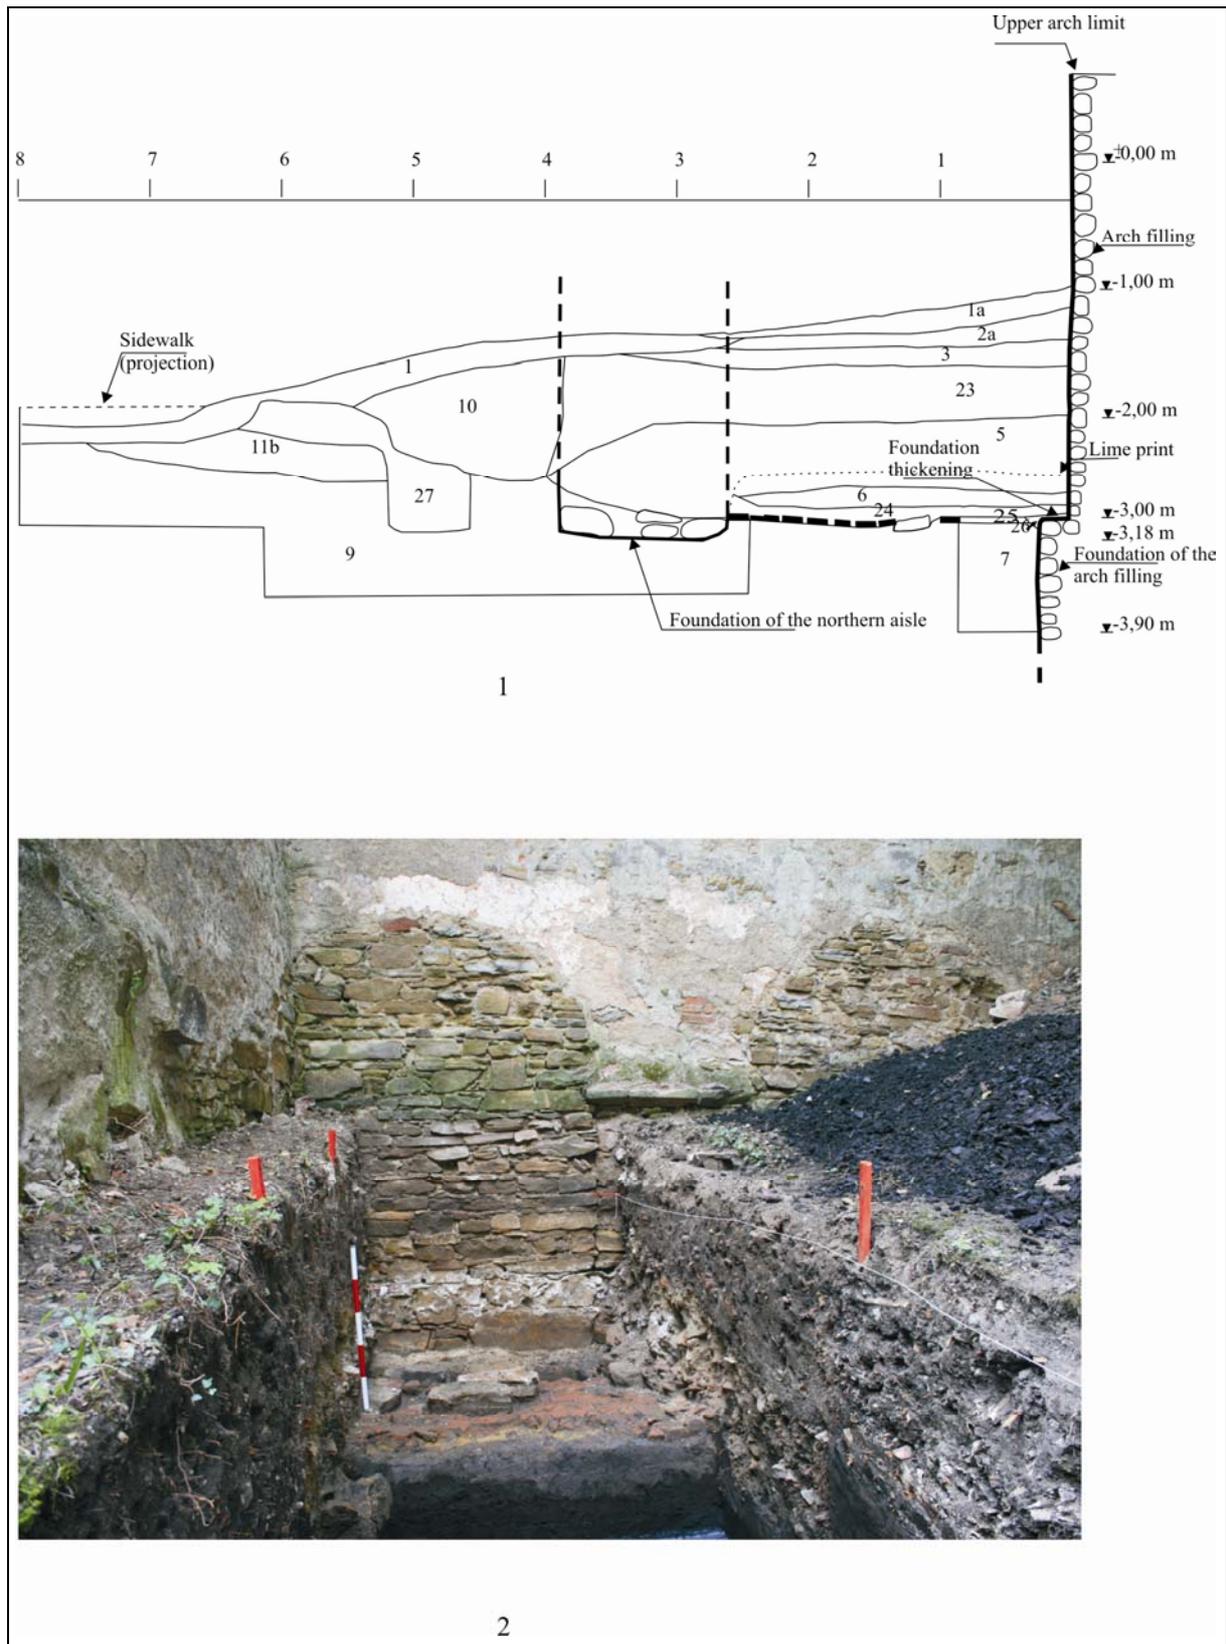
Pl. 6. 1. Eastern profile of trench 1 next to the church. 2. General view toward the current church wall, with traces of the arcade between the aisles.

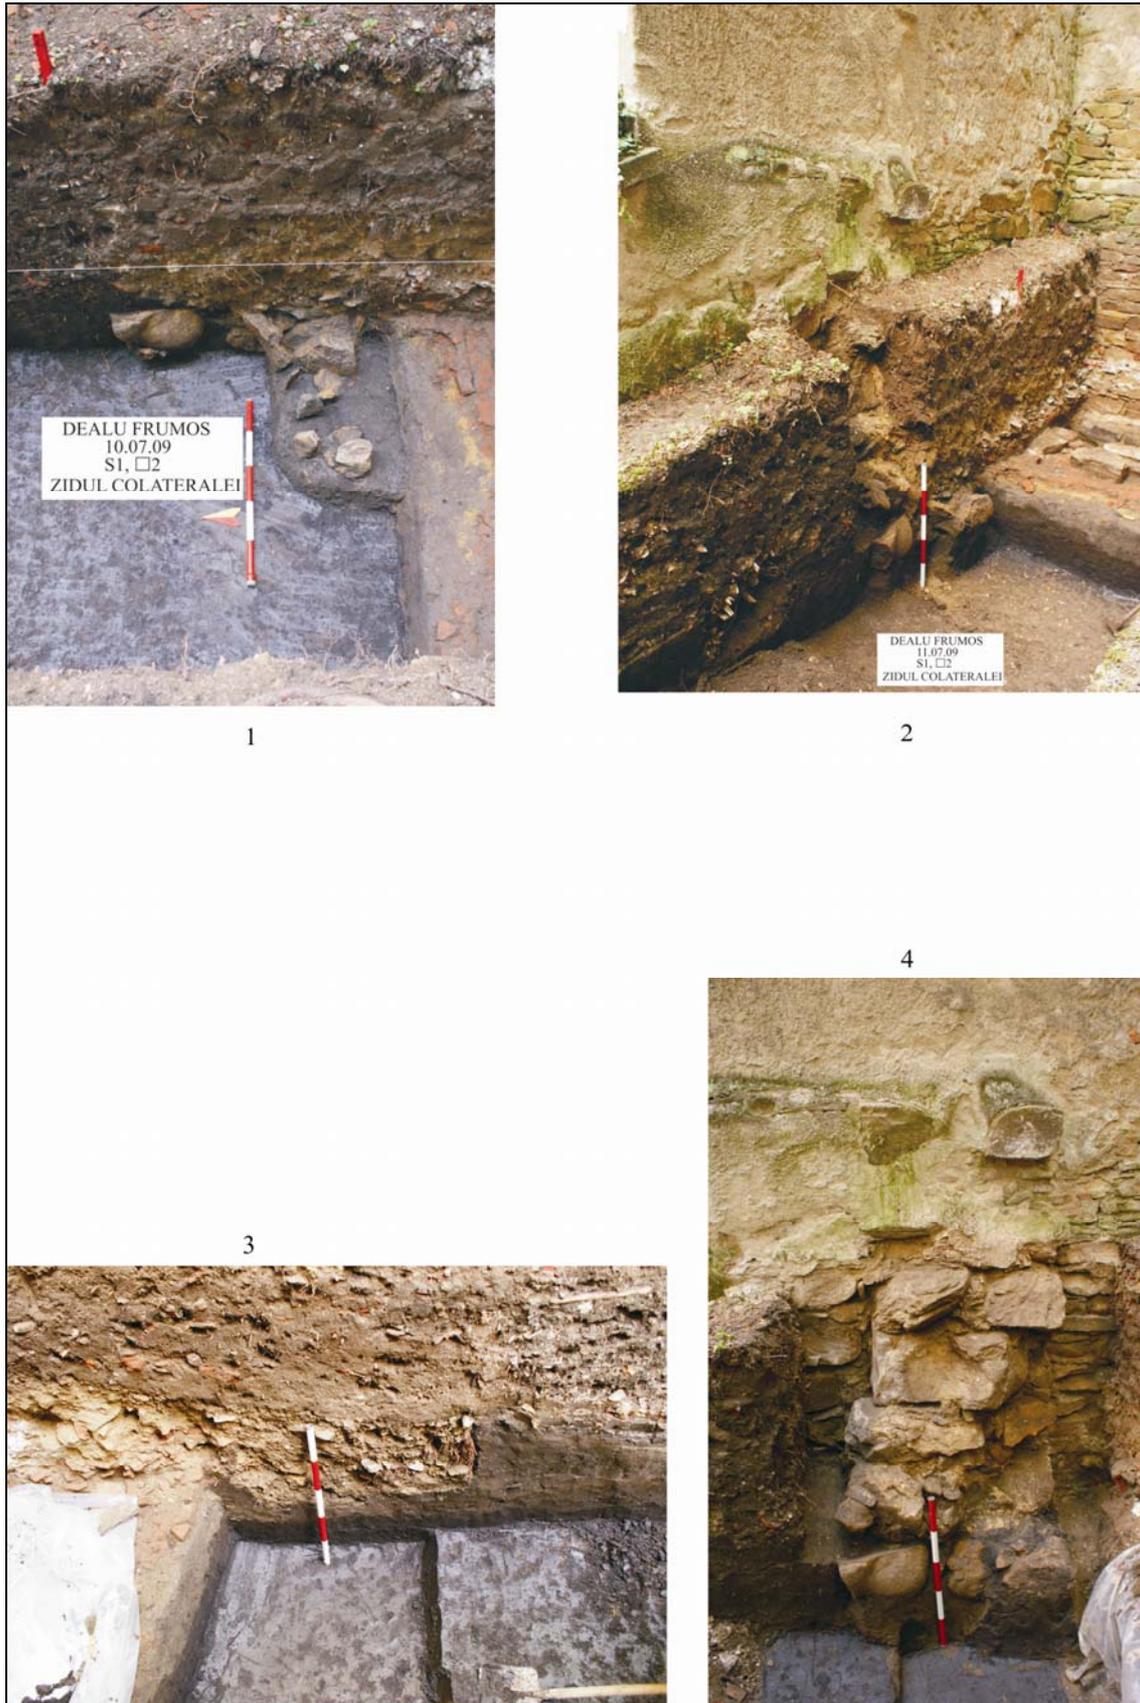
Pl.7. 1–2, 4. Ruin of the exterior wall of the northern aisle, at the end of the excavation. Preserved only few of the boulders of the foundation base. 3. Aisle foundation dismantling ditch.

- Pl. 7. 1–2, 4. Ruin of the exterior wall of the northern aisle, at the end of the excavation. Preserved only few of the boulders of the foundation base. 3. Aisle foundation dismantling ditch.

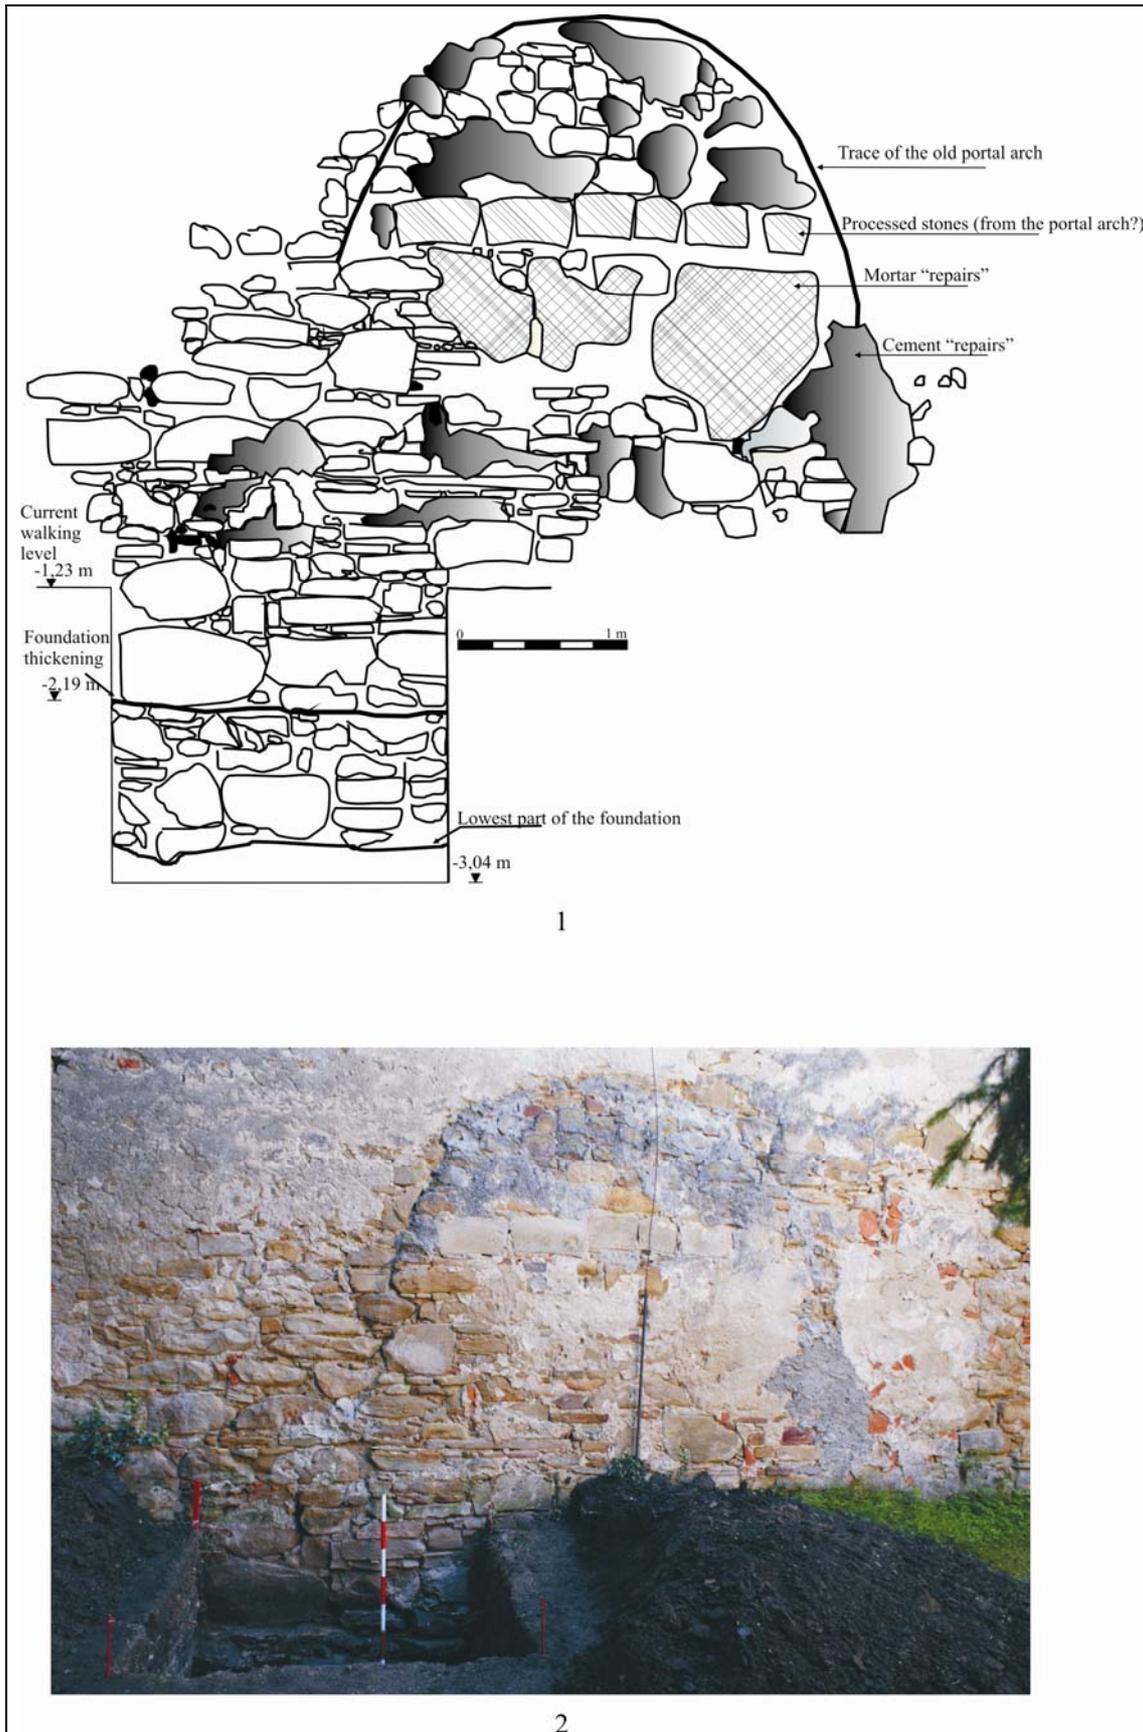
Pl. 8. 1. Current western church wall next to trench 2. 2. General view toward the western church wall, during the excavations. One can see the imprint of the supposed portal.

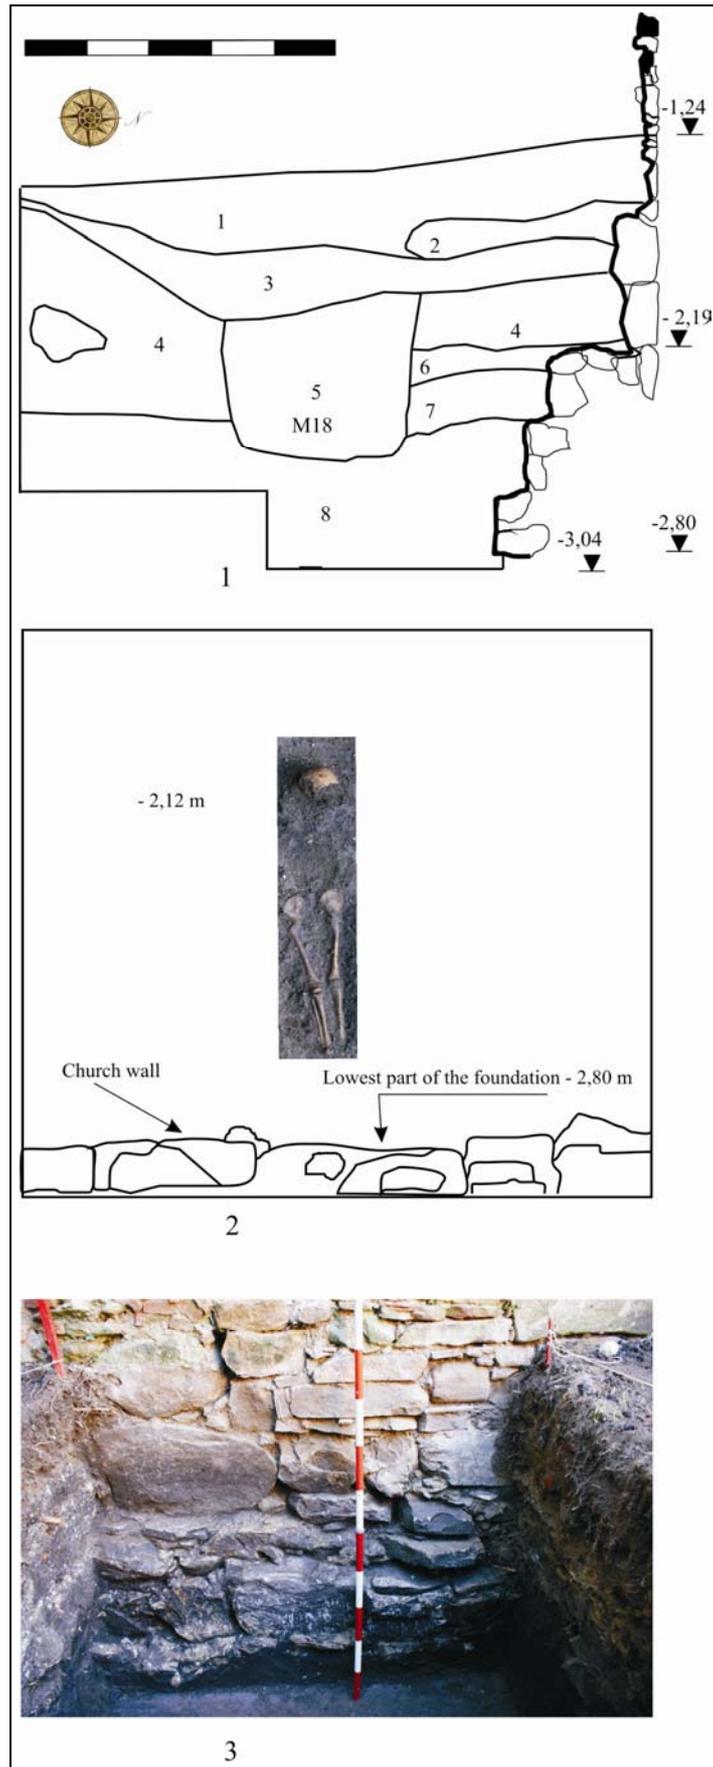
Pl. 9. 1. Northern profile of trench 2. 2. Plan of trench 2. 3. Detail of the western tower foundation base.

- Pl. 9. 1. Northern profile of trench 2. 2. Plan of trench 2. 3. Detail of the western tower foundation base.
- Pl. 10. 1. General plan of trench 3, with the apse ruin. 2–3. Photos during the excavations in trench 3.

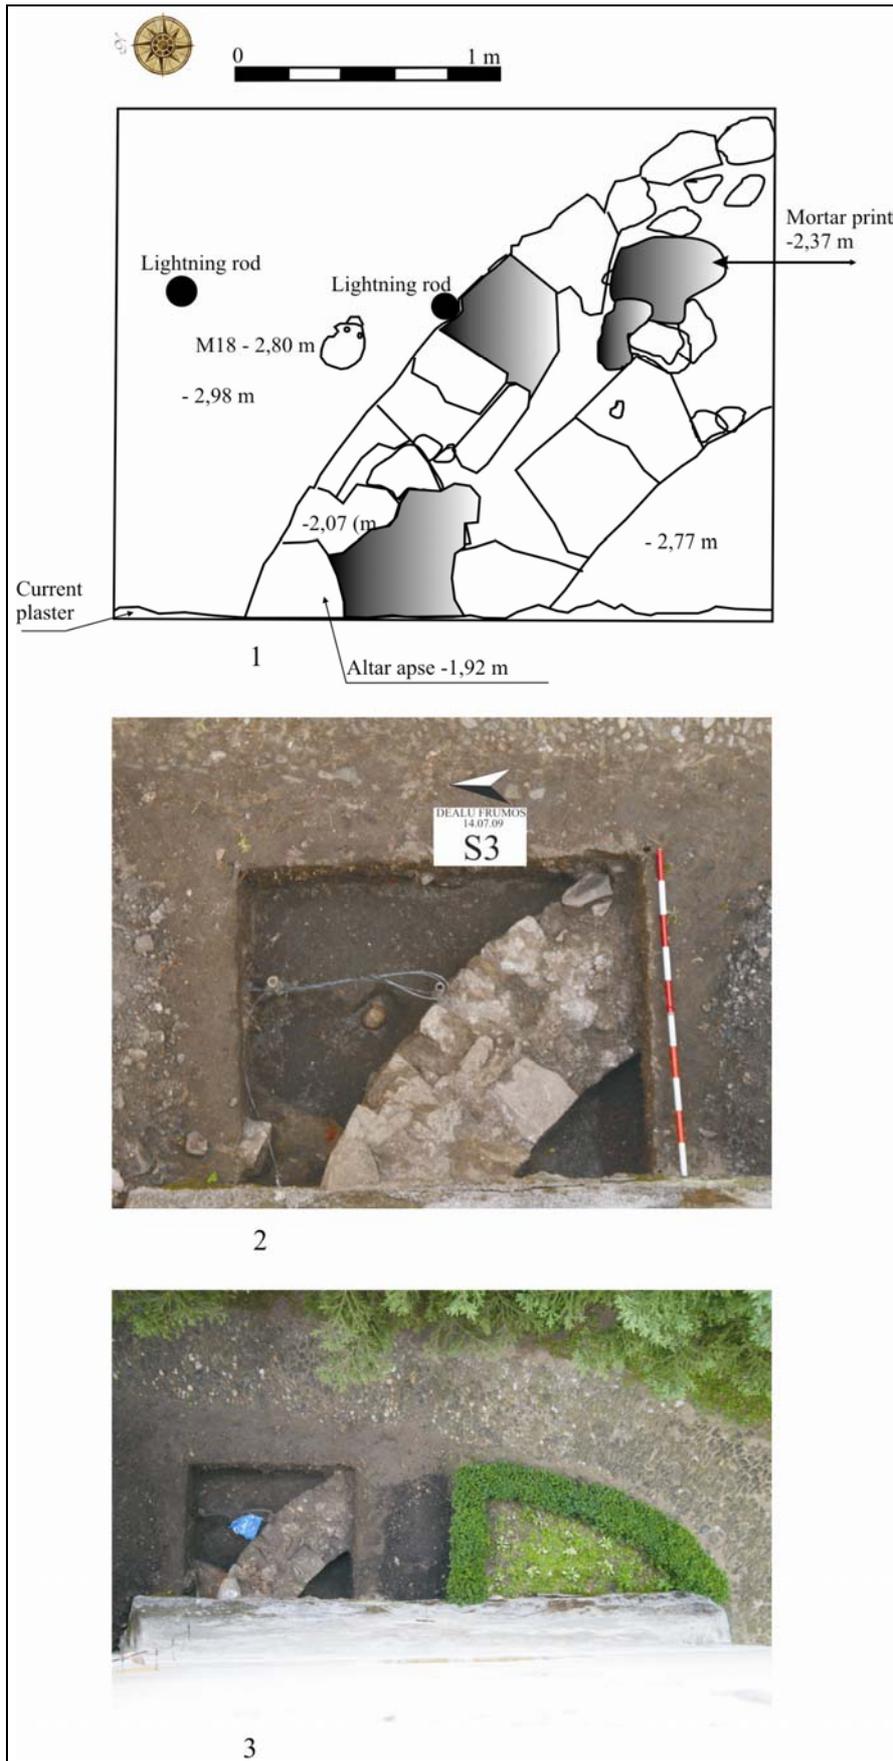
Pl. 10. 1. General plan of trench 3, with the apse ruin. 2–3. Photos during the excavations in trench 3.

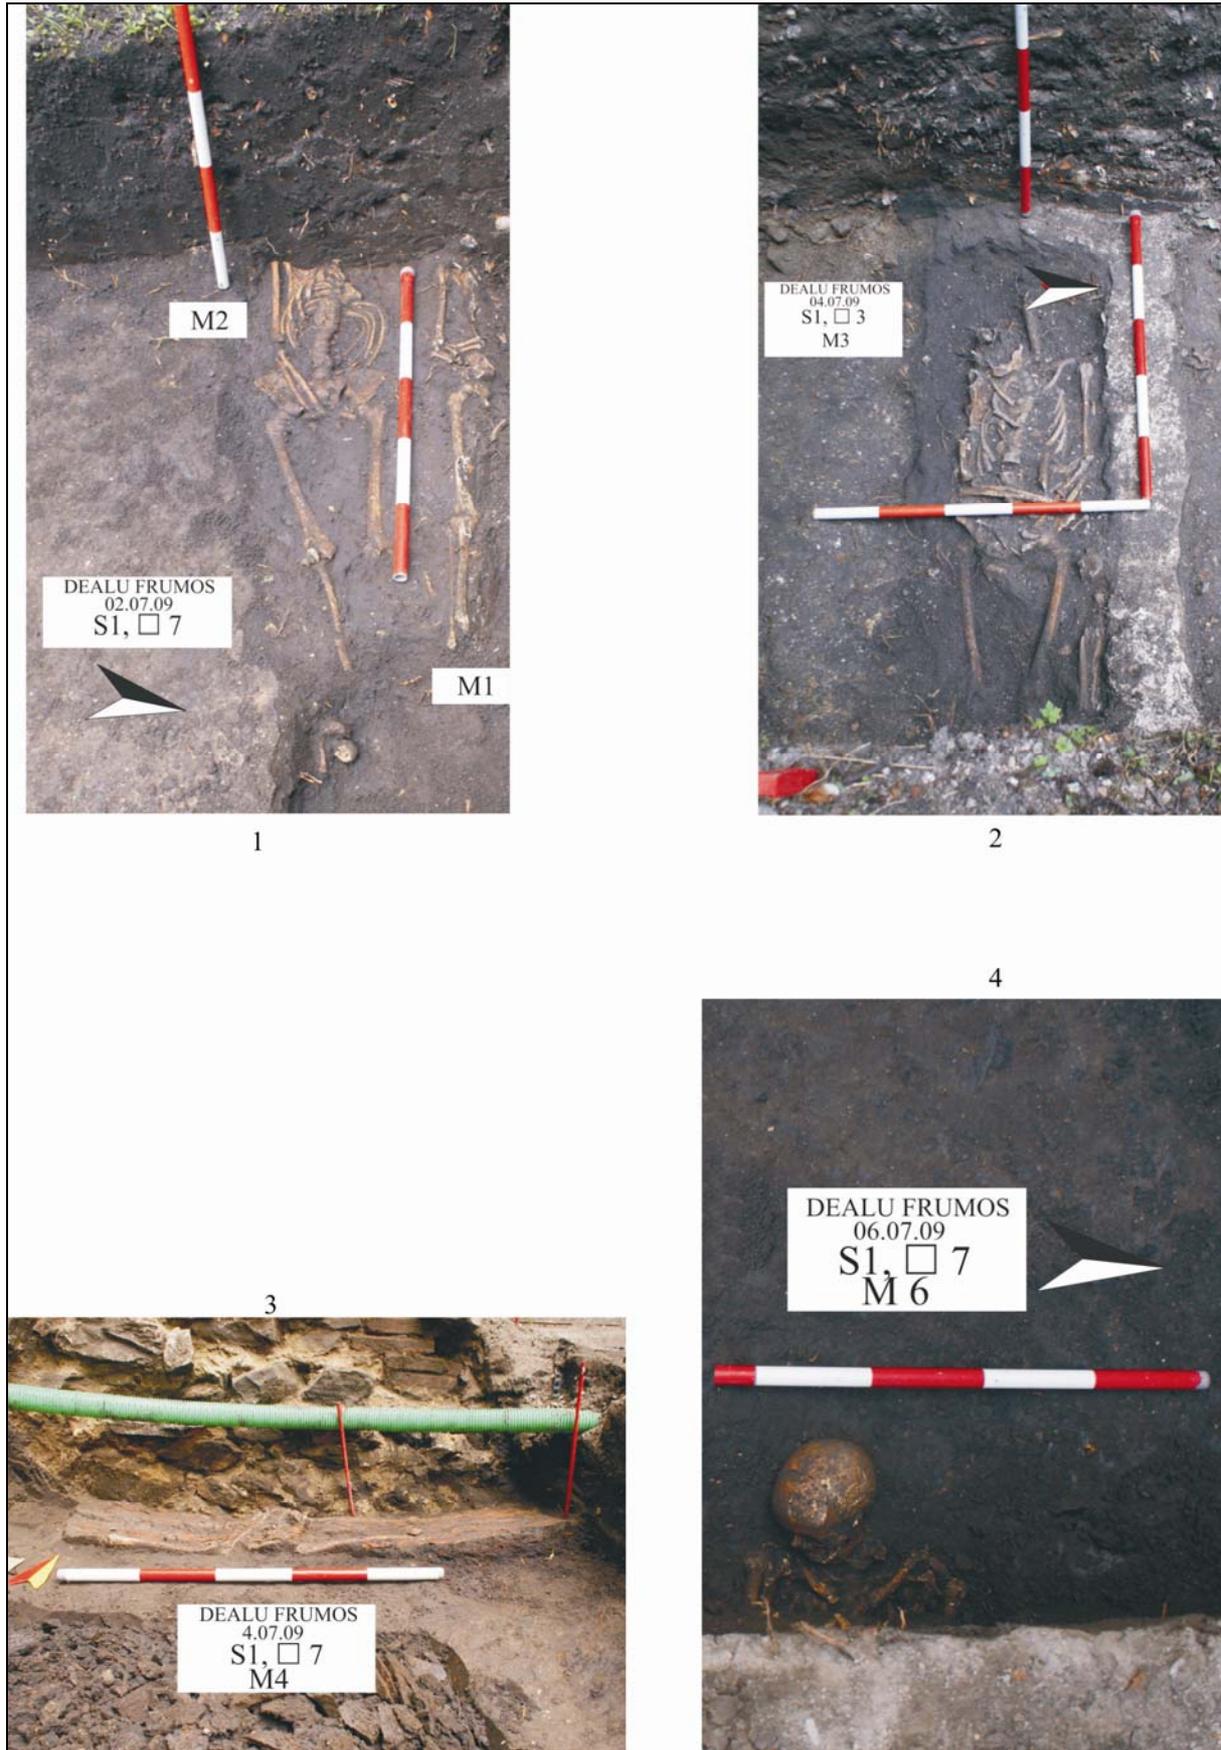
Pl. 11. Graves discovered during the excavations.

- Pl. 11. Graves discovered during the excavations.
- Pl. 12. Graves discovered during the excavations.

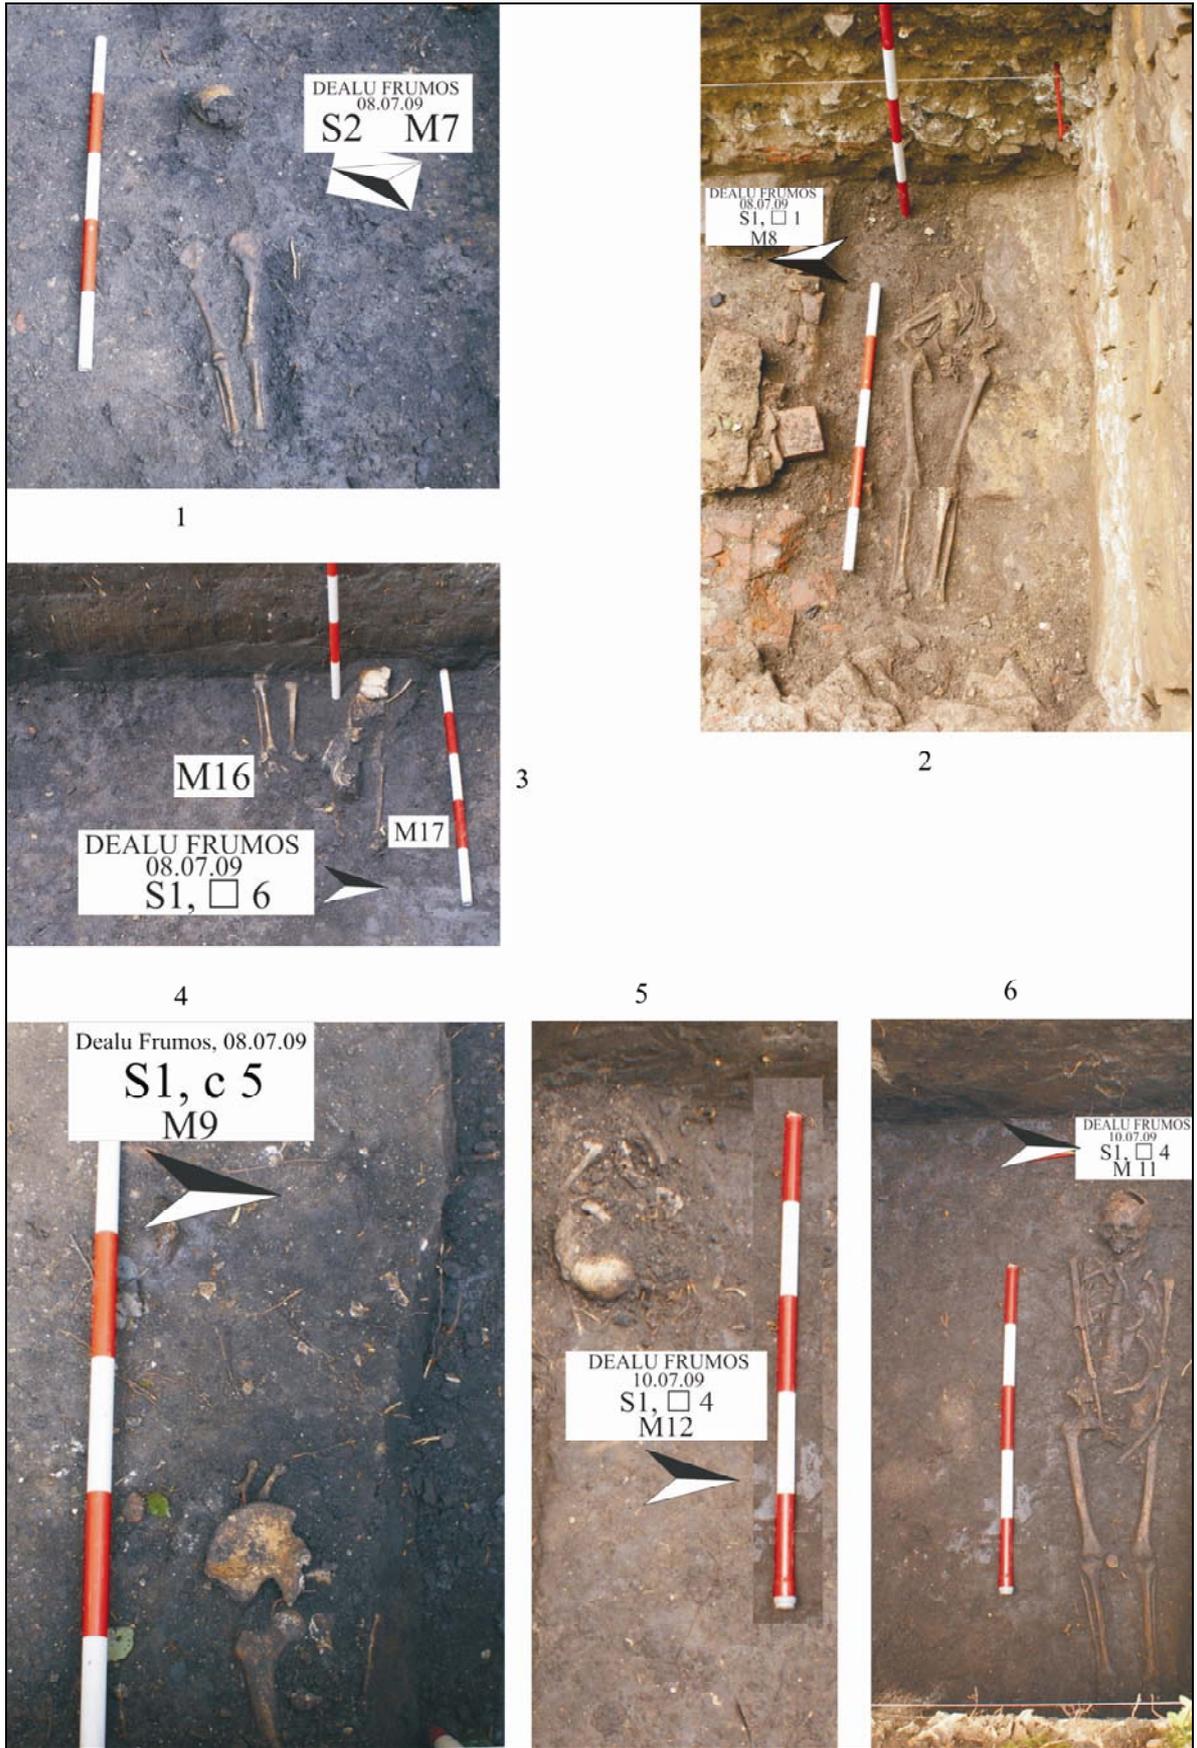
Pl. 12. Graves discovered during the excavations.
